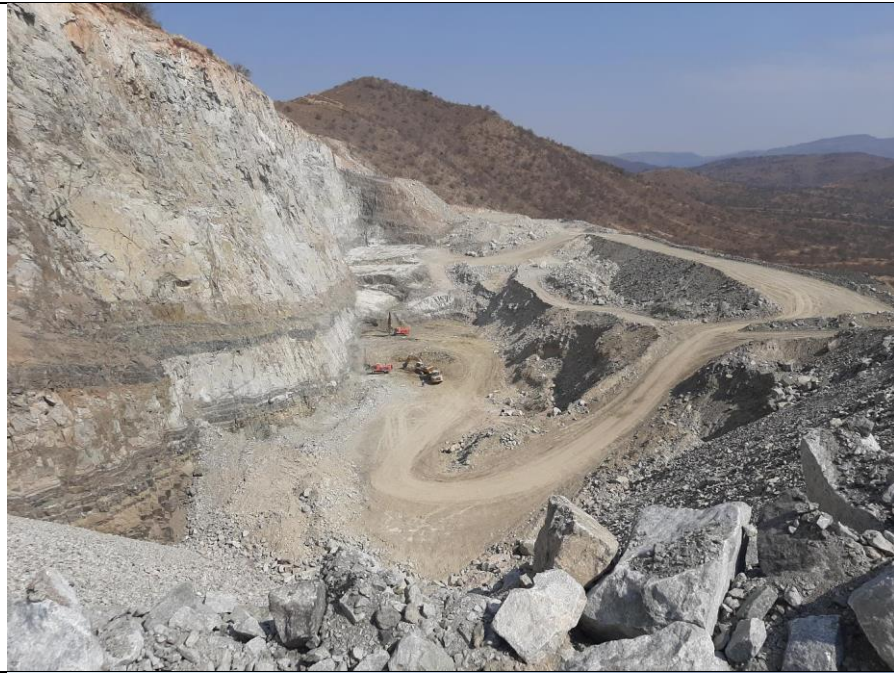
Photo 1

Area: Pit 1

Observations: This photo is of the old and largest pit. The pit is more towards the NW of the mining area. The pit is still being mined and thus active.

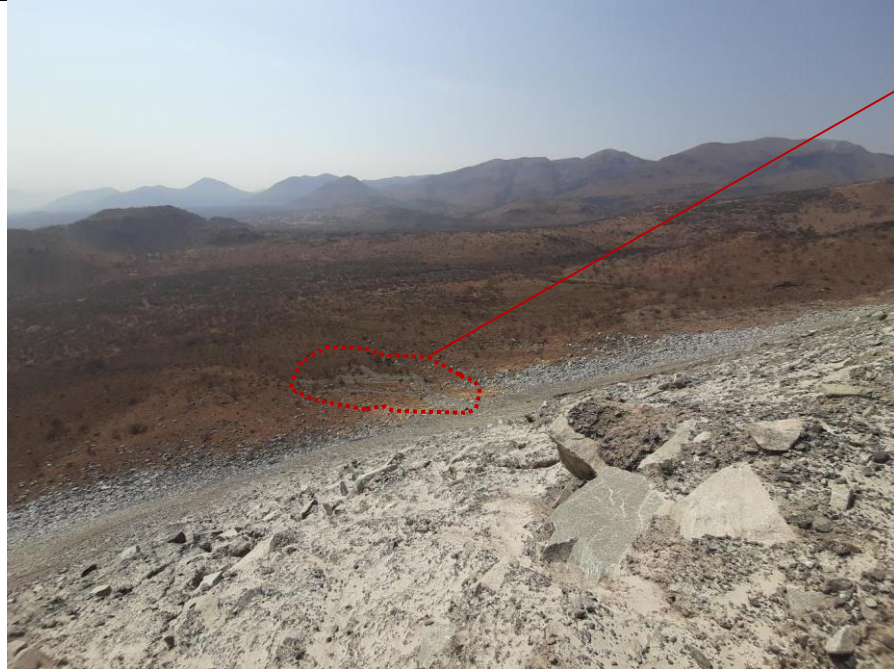
Sediment from erosion collecting near the foot of the discard dumps.

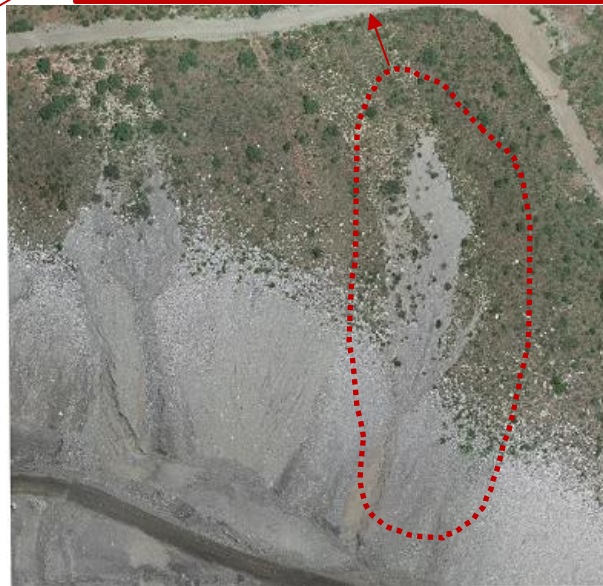
Photo 2

Area: Slag dump

Observations: This photo is of the stream that flows past the slag dump. The stream cuts into the slag dump footprint. This is the same stream as is referred to in the EMP as the stream diversion

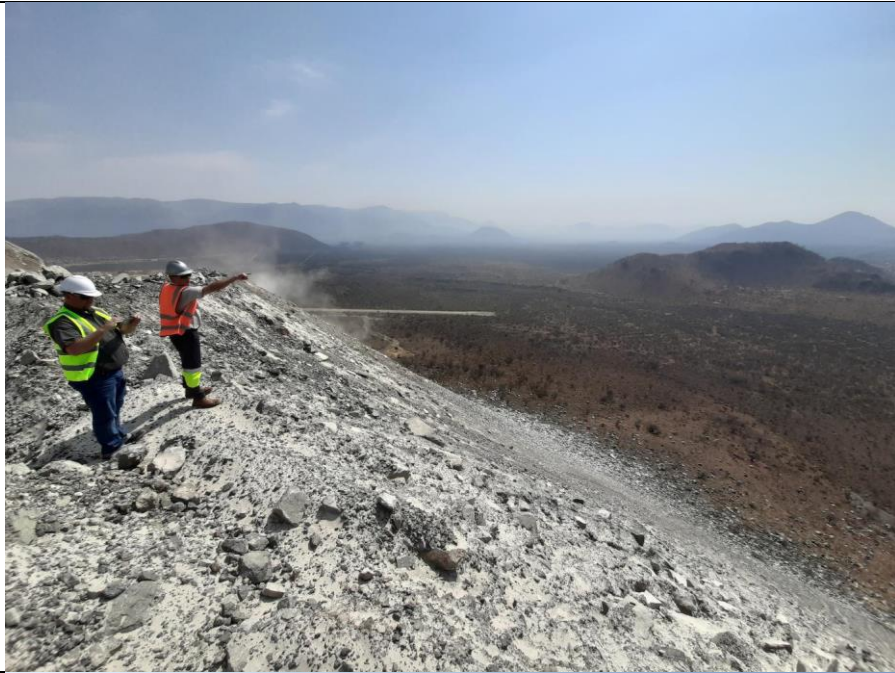
Photo 2

Area: Discard dumps at mining area

Observations: This photo is on top of the discard dumps near the mining area looking NNW in the direction of the Glencore Lion smelter and BCR's landing strip. Some dust can be observed.

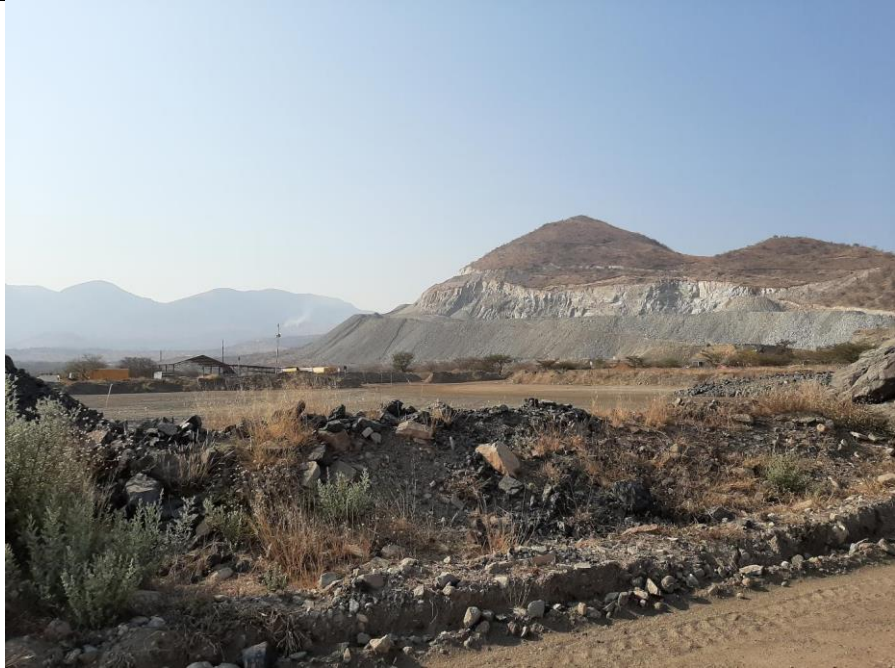
Photo 3

Area: At the RoM laydown area looking towards the mining area

Observations: This photo is of the mining area and is taken from the RoM laydown area near the mine offices, looking SE towards the mining area.

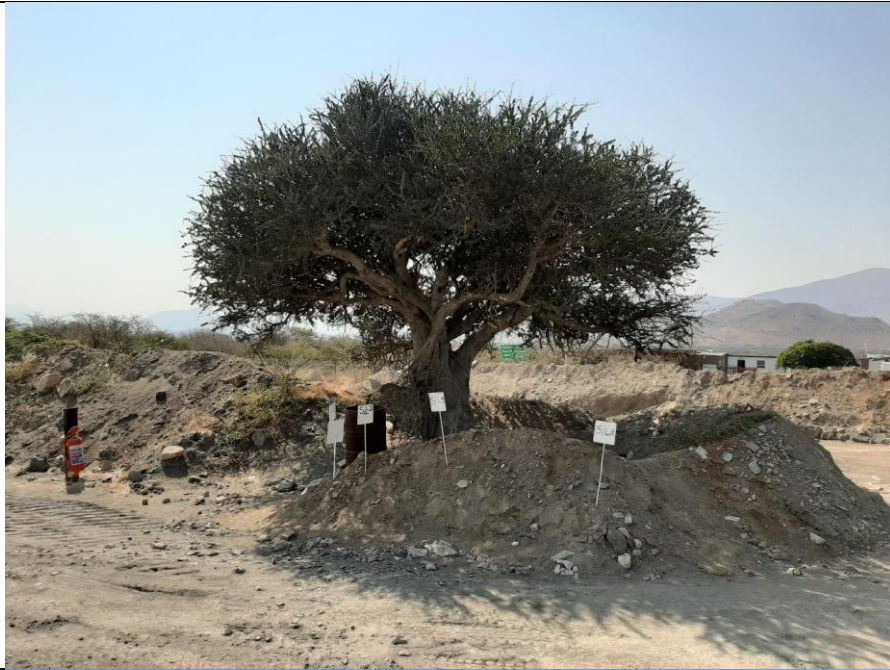
Photo 4

Area: Office, laydown and workshop area
Observations: This photo is of a protected *Boscia sp.* that has been left protected. The berms are a mixture of subsoil and topsoil.

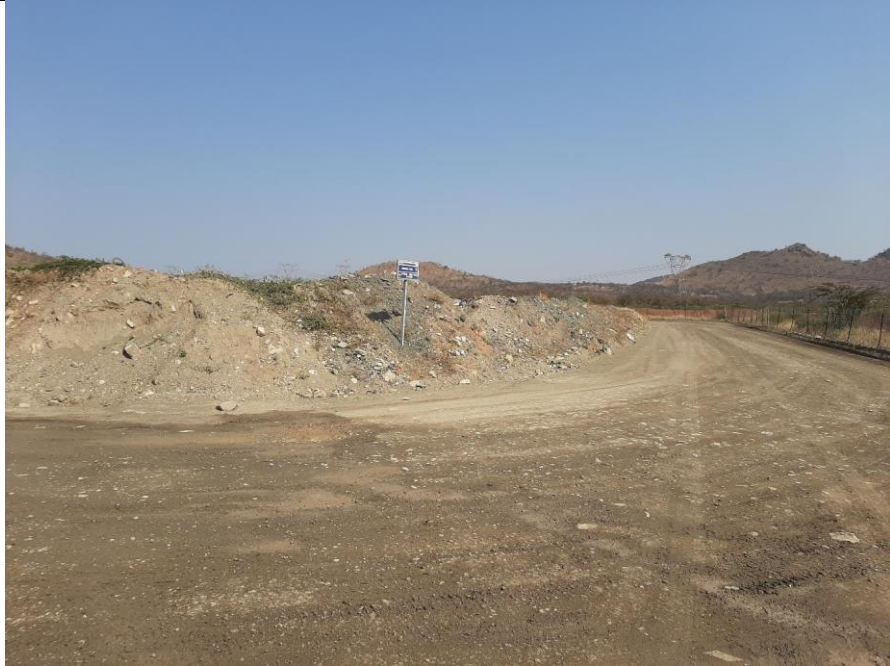
Photo 5

Area: Hauling road near the RoM laydown area and offices
Observations: This photo is of the hauling road near the RoM stockpiles and office area. The dust suppression can be observed on the road. The berms are mostly subsoil. Alien and invasives species can be observed on the berms.

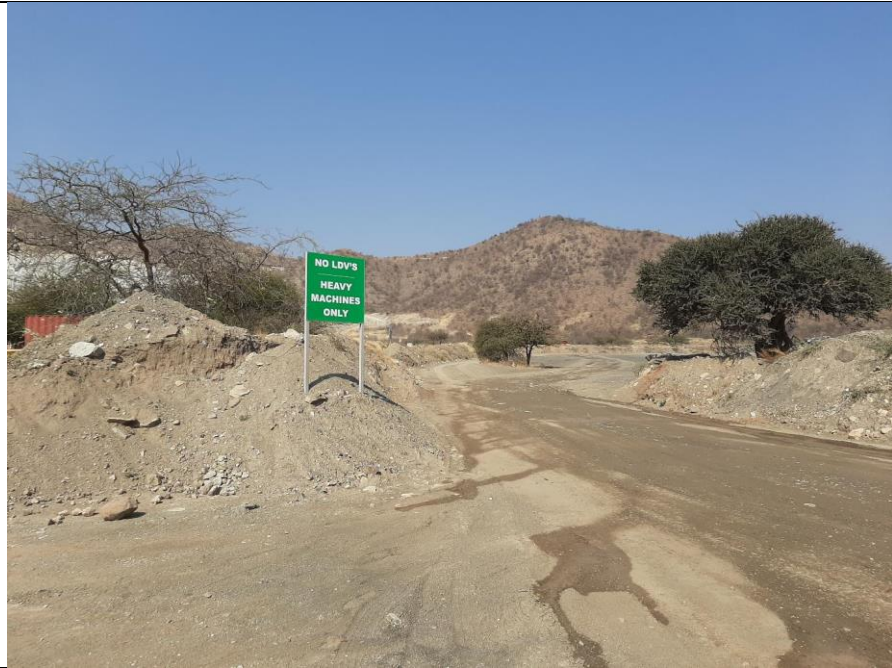
Photo 6

Area: Mine offices and RoM

Observations: This photo is of the hauling road and berms near the offices. The dust suppression can be observed. Notice boards can be observed restricting access to heavy vehicles.

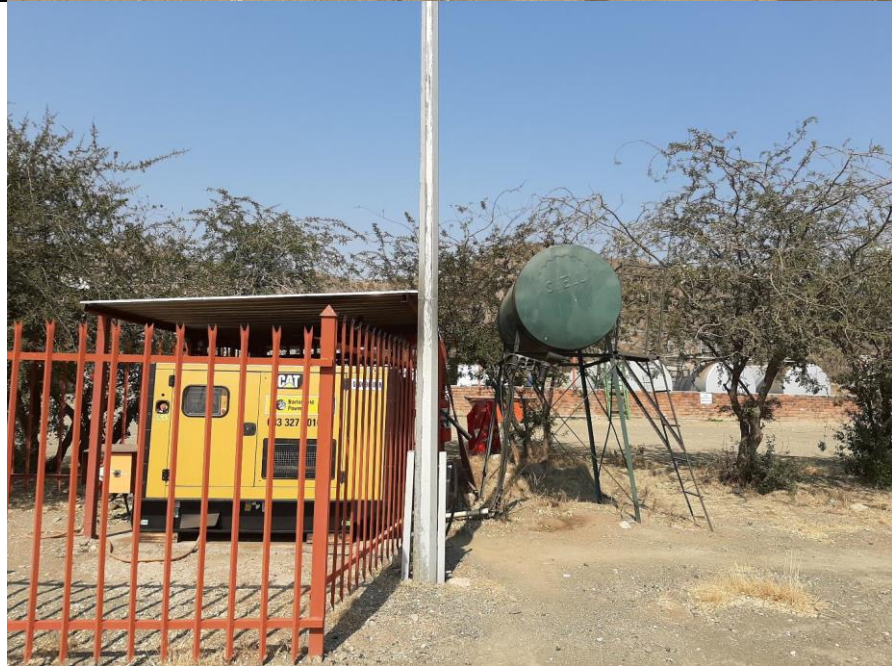
Photo 7

Area: Office area

Observations: This photo is of the generator fuel tank and electrical generator. No berms around the generator or fuel tank. Area general clean with only one small spillage at the fuel tank.

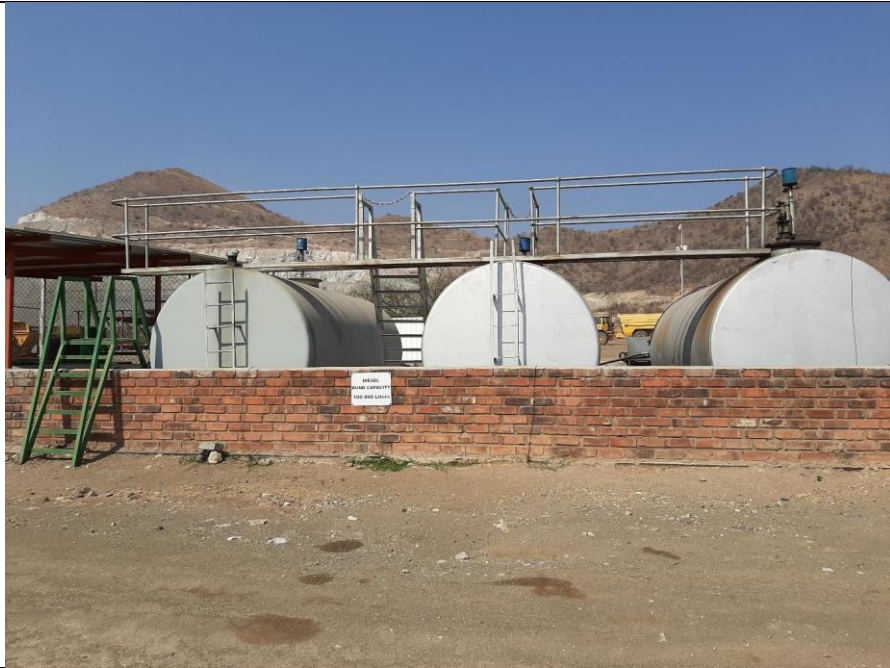
Photo 8

Area: Fuel tanks

Observations: This photo is of the main fuel tanks. Bund wall with capacity display are observed.

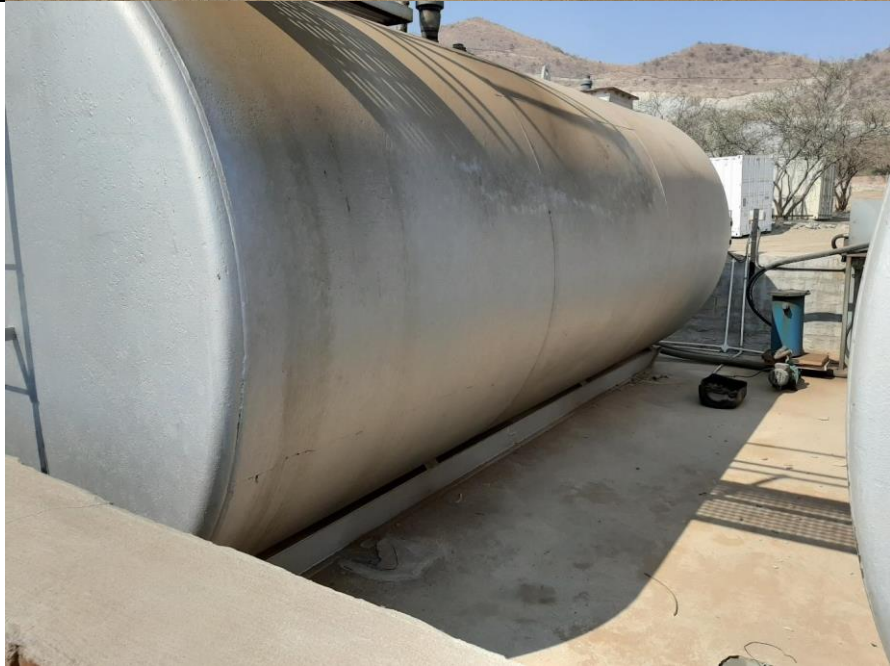
Photo 9

Area: Fuel tanks

Observations: This photo is of the main fuel tanks. Bund wall are observed. Bund wall is clean and neat. No spillages observed.

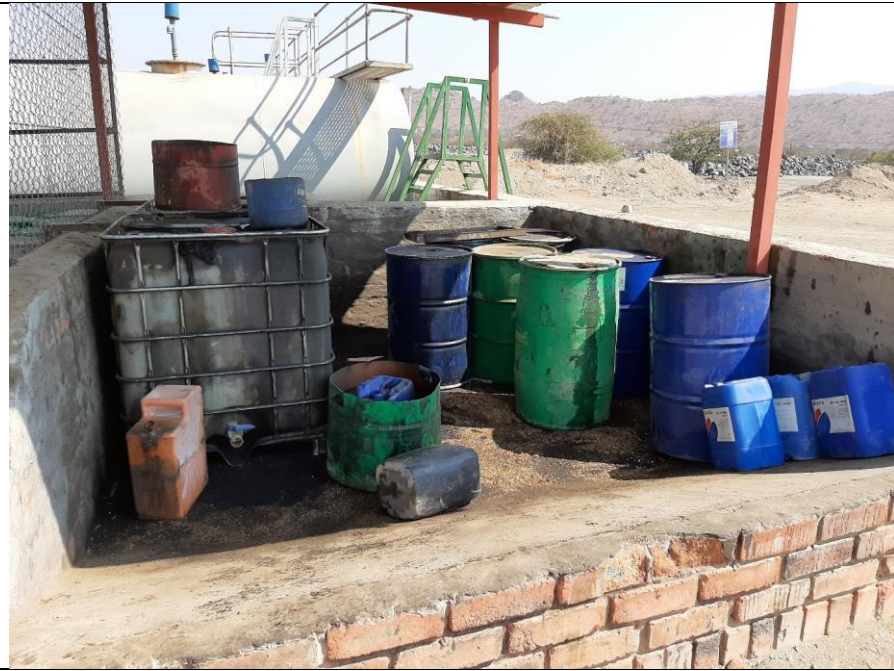
Photo 10

Area: Hazchem store.

Observations: This photo is of the hazchem area. It can be observed that the containers are not labelled. Spillages are visible but treated with absorbent. The absorbent were not yet removed to the hazardous waste bin. Housekeeping in the hazchem area are poor.

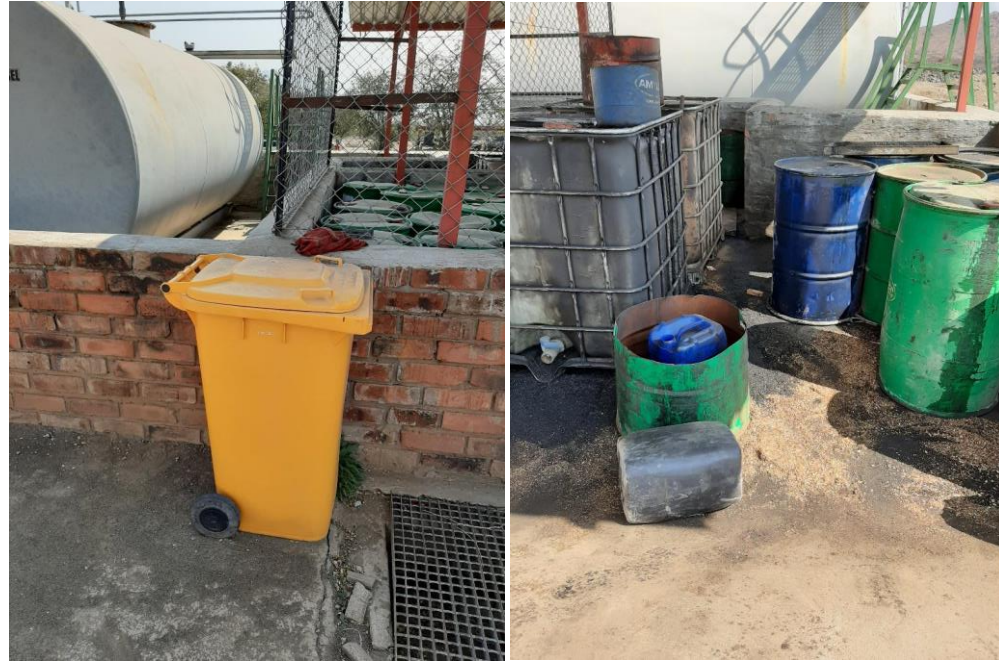
Photo 11

Area: Hazchem area.

Observations: This photo is of the spill kit and hazchem store. See comments on photo 10.

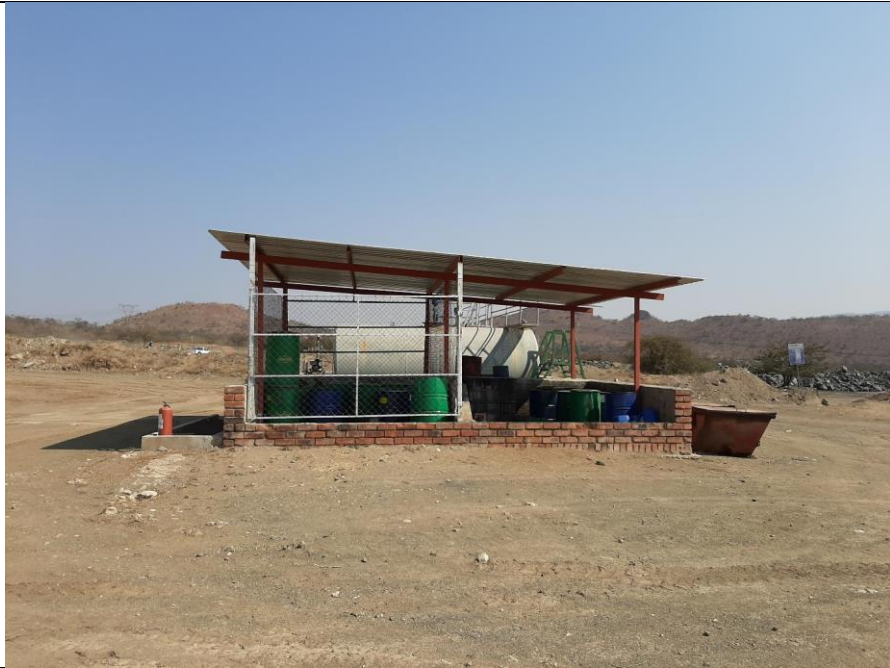
Photo 12

Area: Hazchem store.

Observations: This photo is of the hazchem store. The store is well ventilated and has a roof. The oil store is locked. The hazardous waste bin can be observed in the photo on the right of the hazchem store.

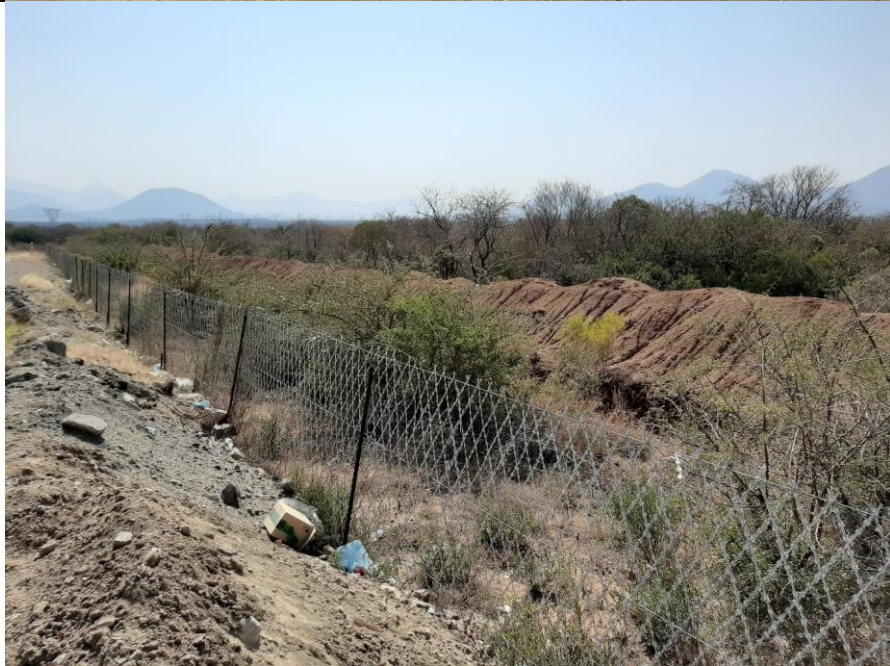
Photo 13

Area: Storm water channel and diversion berm.

Observations: This photo is of the storm water trench and diversion berm. Erosion is visible on the diversion berm, which also serve as the topsoil storage. Some littering are observed near the fence.

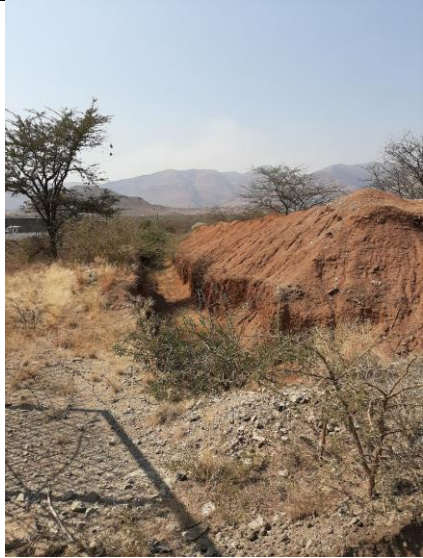
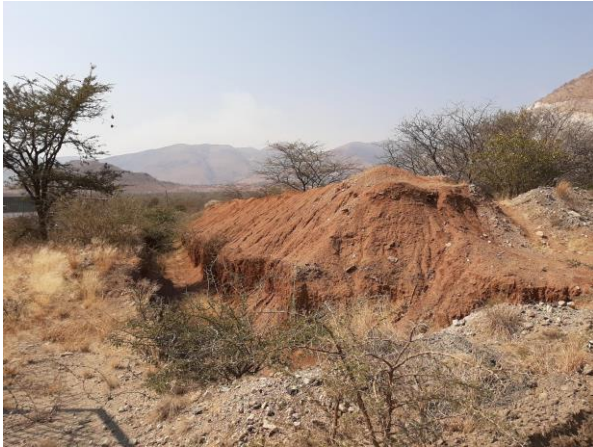
Photo 14

Area: Storm water channel and diversion berm.

Observations: This photo is of the storm water trench and diversion berm. Erosion is visible on the diversion berm, which also serve as the topsoil stockpile.

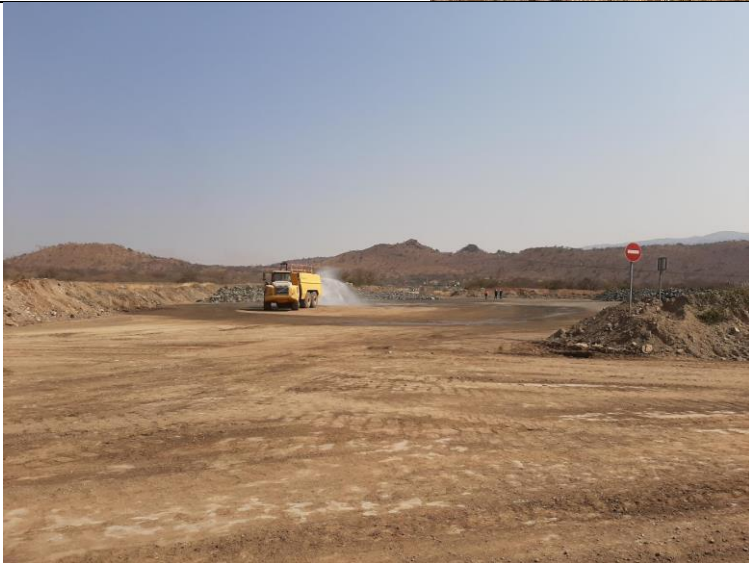
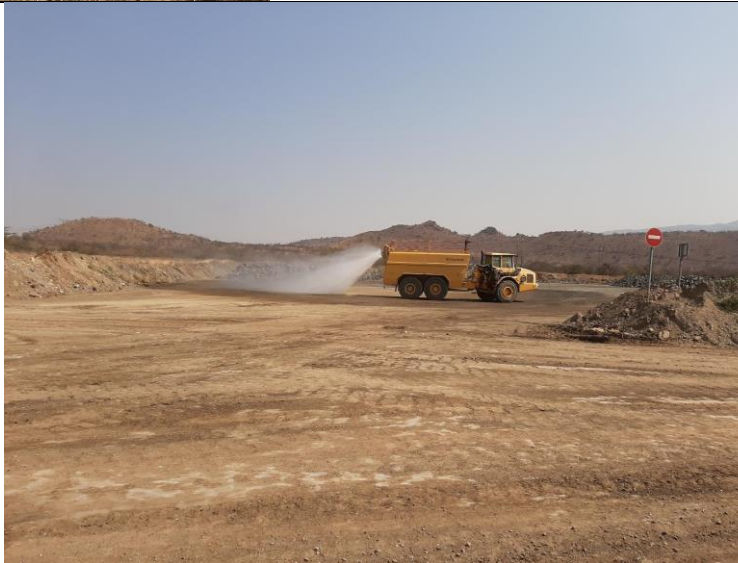
Photo 15

Area: Haul road near RoM and workshop.

Observations: This photo is of the haul road near RoM and the workshop. Dust suppression is being done.

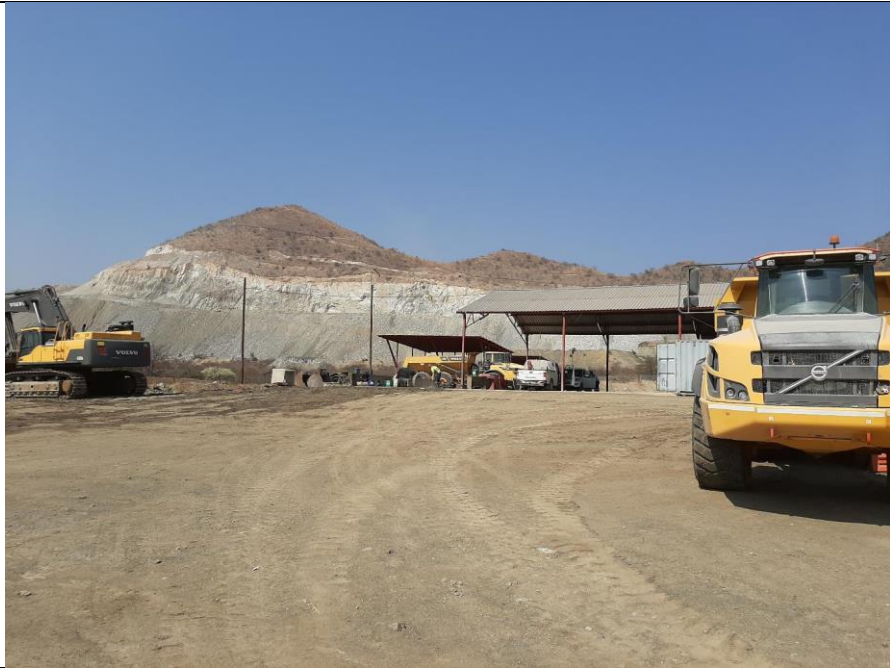
Photo 16

Area: Workshop area.

Observations: This photo is of the workshop area. Washwater can be observed in the photo as it runs off from the workshop surface (not collected or contained). Workshop is roofed and housekeeping good.

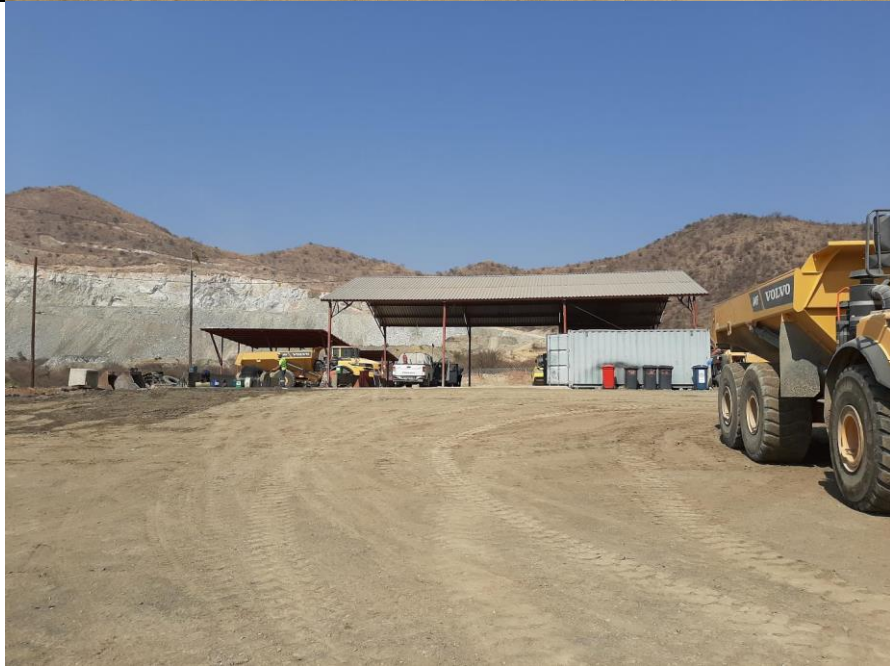
Photo 17

Area: Workshop area.

Observations: This photo is of the workshop area. Washwater can be observed in the photo as it runs off from the workshop surface (not collected or contained). Workshop is roofed and housekeeping good.

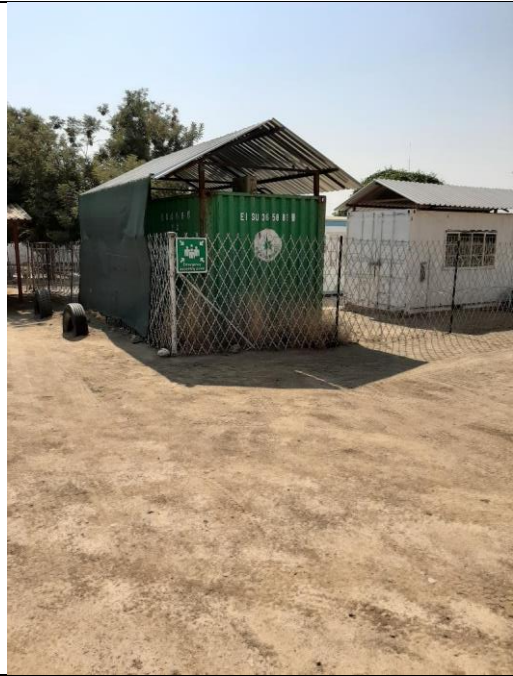
Photo 18

Area: Offices (emergency assembly point).
Observations: This photo is a photo of the emergency assembly point.

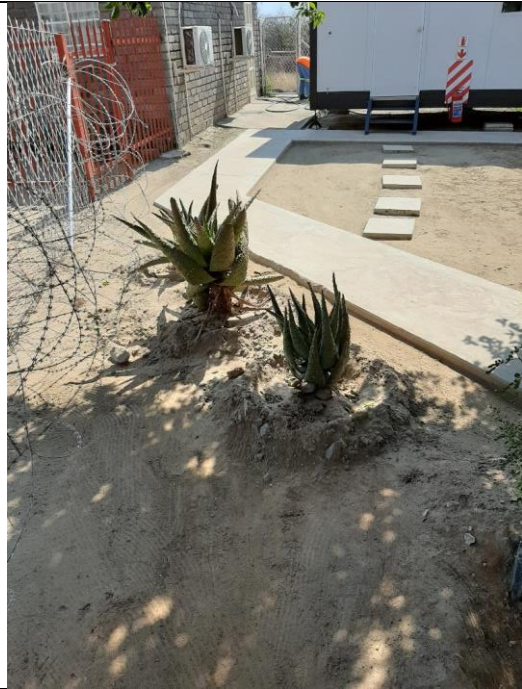
Photo 19

Area: Office area.

Observations: This photo is of the rescued *Aloe sp.*

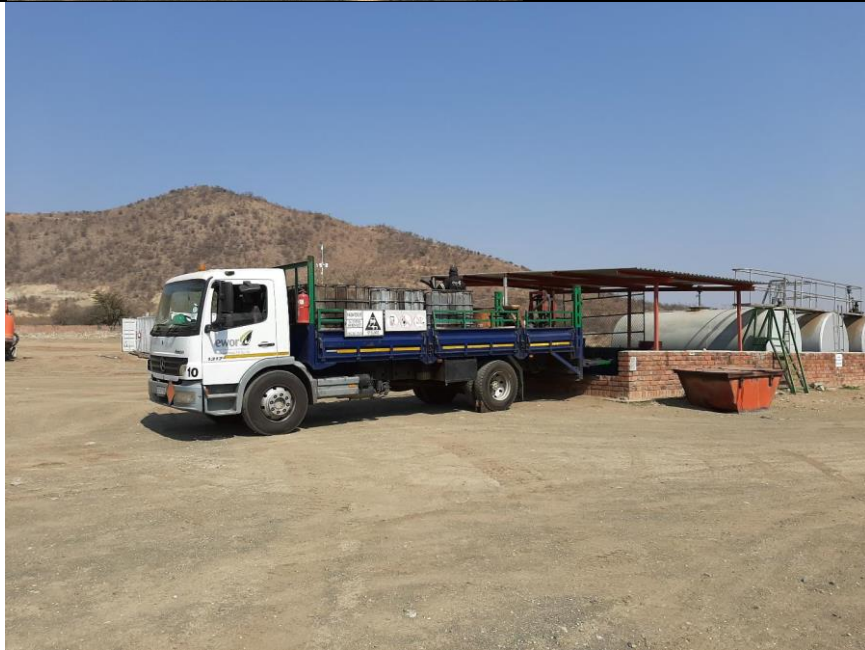
Photo 20

Area: Hazchem area.

Observations: This photo is of the used oil collection taking place. In the photo the hazardous waste bin can be observed stored on bare soil.

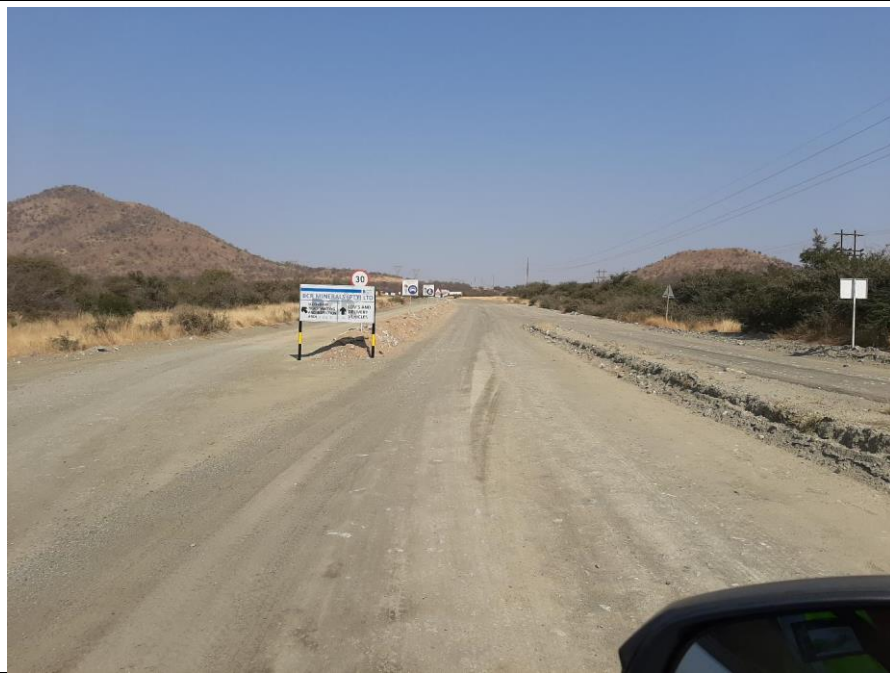
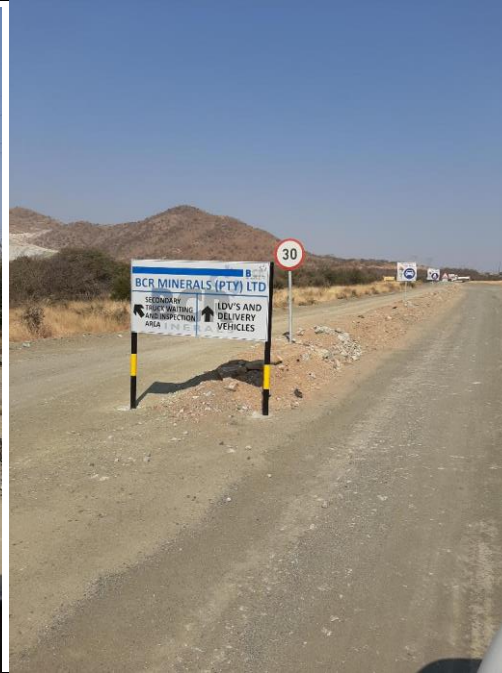
Photo 21

Area: Main access road.

Observations: This photo is of the entrance to the site via the main access road. The notice boards indicates access routes and speed limits (30 km/h).

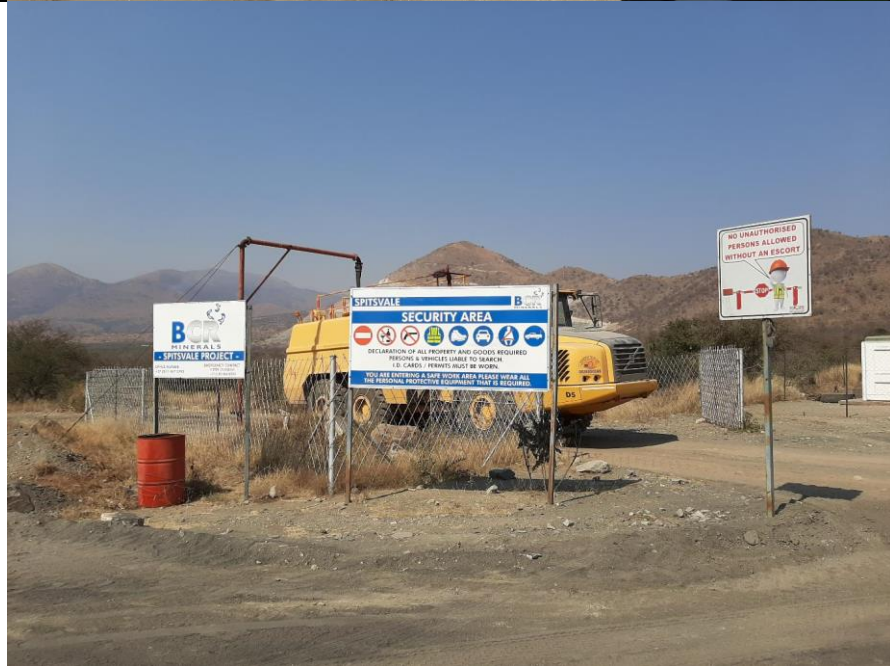
Photo 22

Area: Main access road.

Observations: This photo is of the entrance to the site. The notice boards indicates that it is a security area and that unauthorised access is prohibited. It also indicates some security requirements when entering the site.

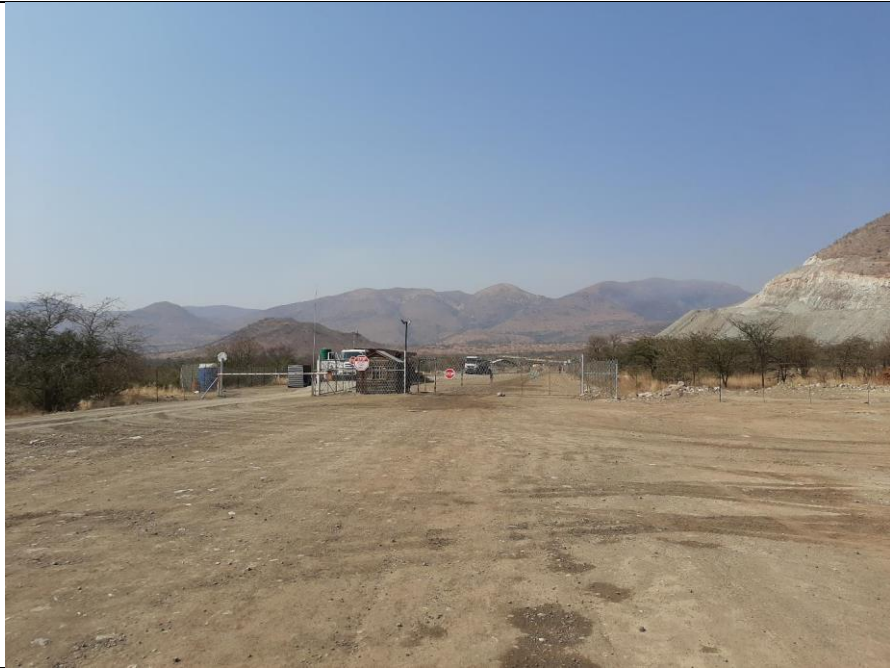
Photo 23

Area: Main security access.

Observations: This photo is of the entrance to the site. The security control can be observed.

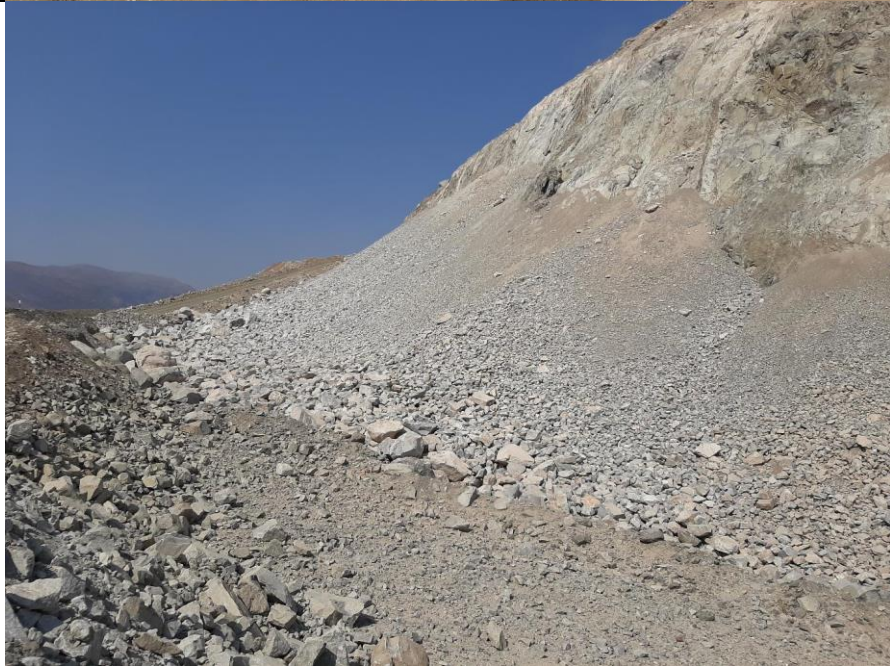
Photo 24

Area: Mining area at pit 1.

Observations: This photo is of the pit 1 mining area. It can be seen how the sequential mining is used to do backfilling. This is an area of the pit that is being backfilled using mining at higher areas.

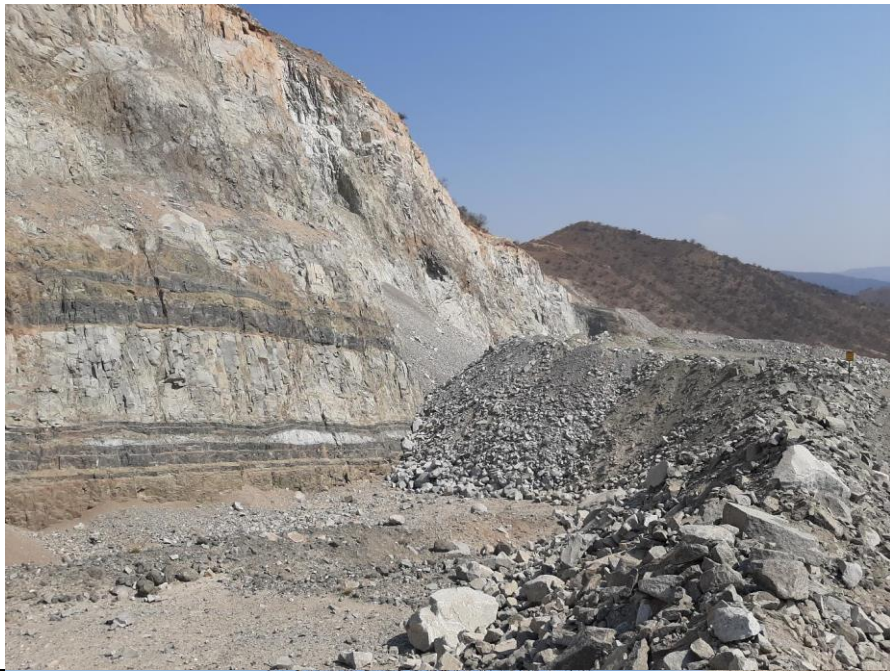
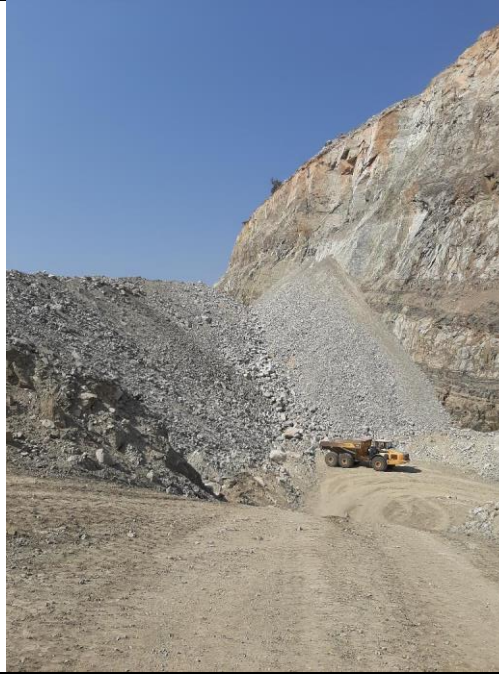
Photo 25

Area: Mining area above pit 1.

Observations: This photo is of the pit 1 mining area. It can be seen how the sequential mining is used to do backfilling. This is an area of the pit that is being backfilled.

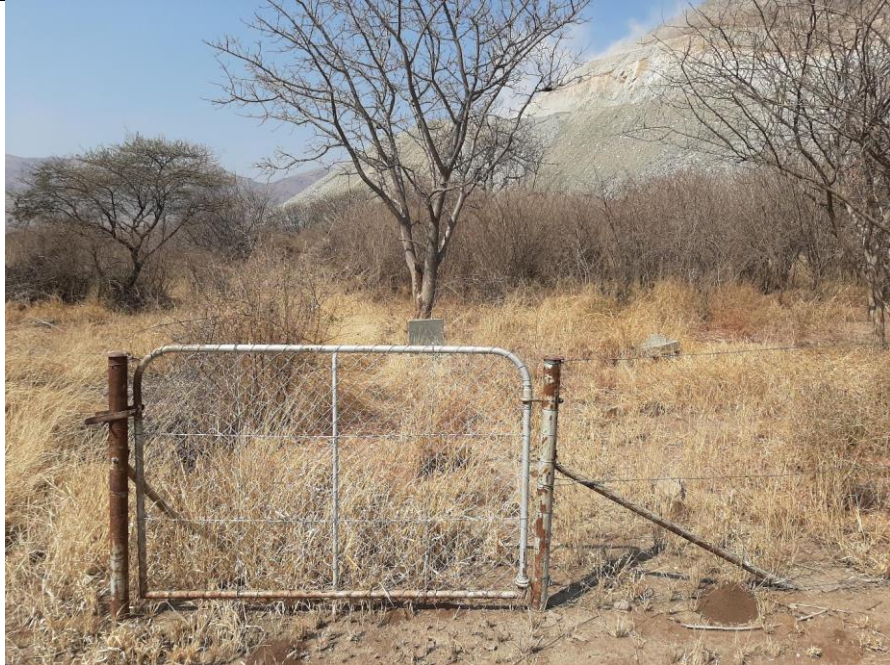
Photo 26

Area: Graves site.

Observations: This photo is one of the graves sites found on the mining area near the main haul road to the mining area. It can be seen that the grave site is fenced off and isolated.

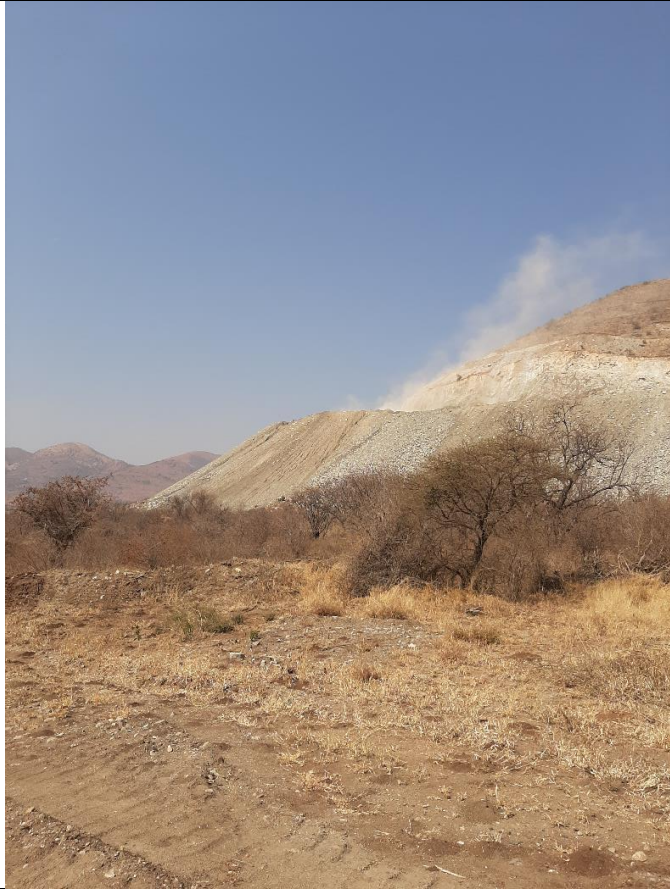
Photo 27

Area: Mining area from the grave site.

Observations: This photo is of the mining area from the near the grave site. A dust cloud can be observed.

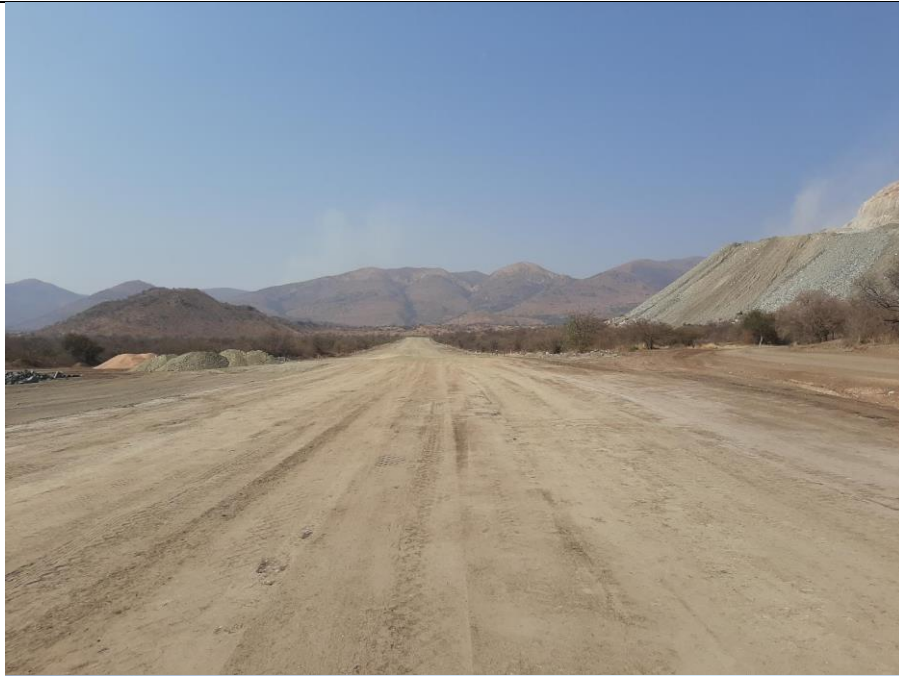
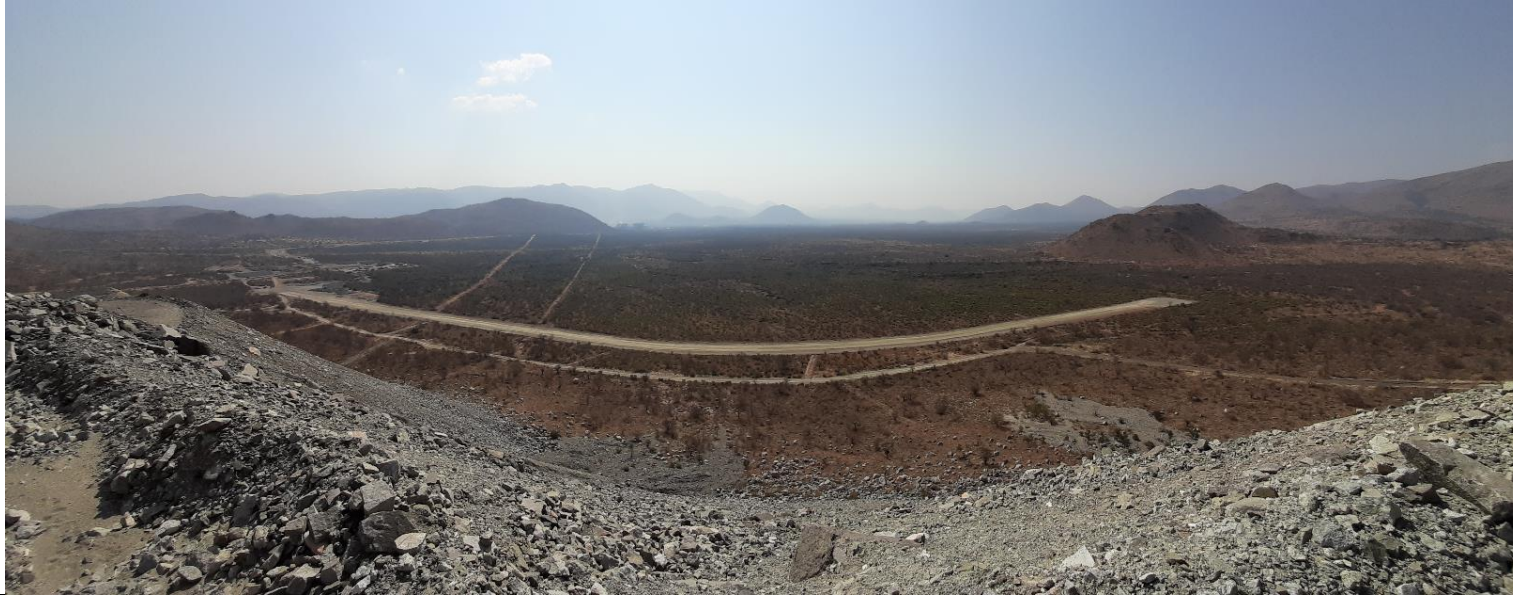
Photo 28

Area: Landing strip.

Observations: This photo is of the recently constructed landing strip. The cleared area can be observed. No topsoil stripping and stockpiling has been observed. The two photos are of the landing strip at the entrance to the landing strip and as taken from the mining area on higher ground.

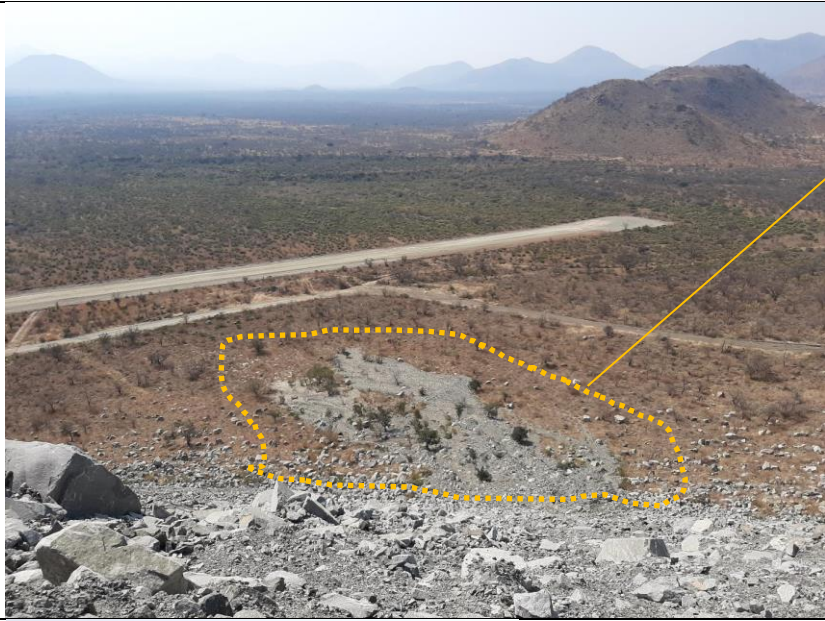
Photo 29

Sediment deposited from erosion. Large scale erosion is taking place from the mining area due to poor runoff control from the mining area.

Area: Mining area.

Observations: This photo is of the mining discard slopes near pit 1 mining area. The landing strip can be clearly observed. Large volumes of sediment can be observed deposited from the mining area due to erosion.

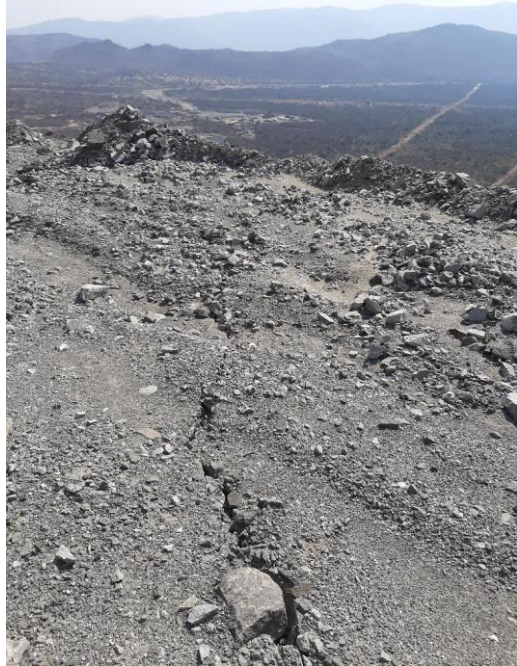
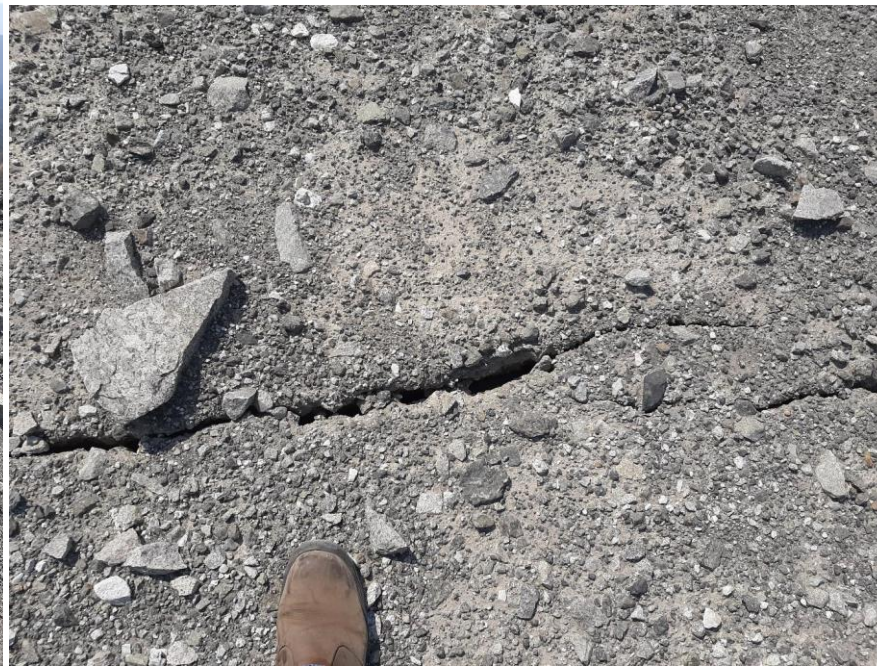
Photo 30

Area: Mining area.

Observations: This photo is of the discard dumps on the top slopes near the mining pits. Cracks can be observed in the discard dumps.
