# EMP audit report

**Project:** BCR/19/01  
**Report:** BCR/19/01/01  
**Operation:** BCR Minerals (Pty) Ltd. -  
Spitsvale

## BCR Minerals (Pty) Ltd – Spitsvale: EMP audit

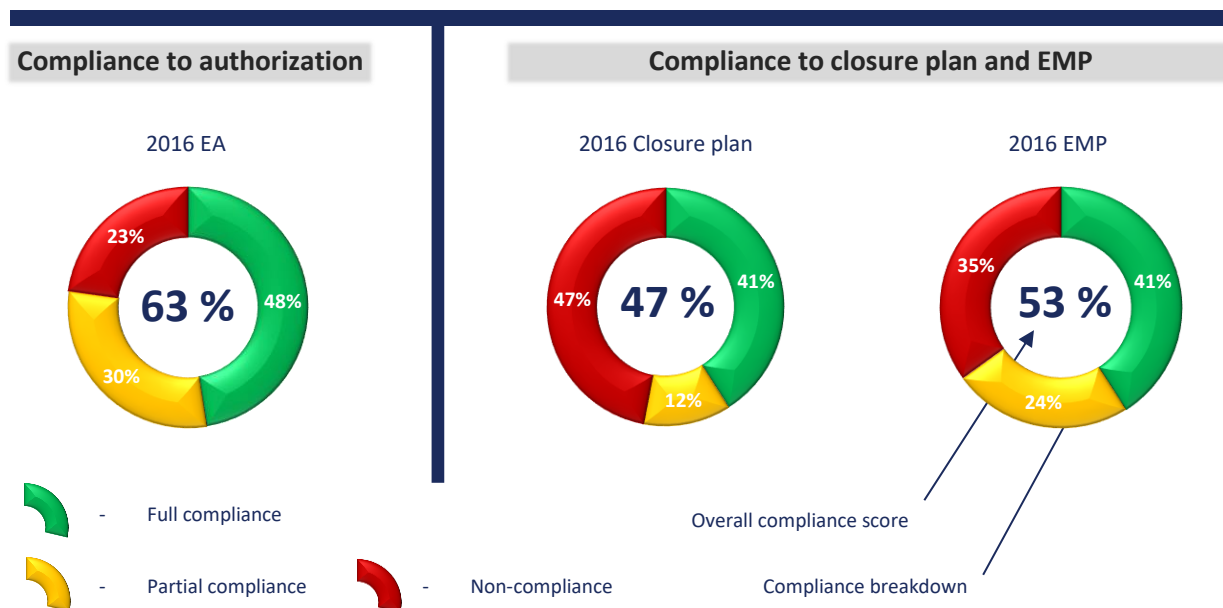
This 2019 Environmental Management Plan (EMP) audit is the first audit done on the operation's environmental authorisation and EMP. The compliance to the 2016 environmental authorization (EA) commitments were 63 % (the overall compliance score (see score calculations in [methodology section](#))), while the compliance with the 2016 EMP commitments was 53 % (overall compliance) and the compliance to the commitments in the closure plan were 47%. The doughnut graphs below provide a further breakdown of the compliance.

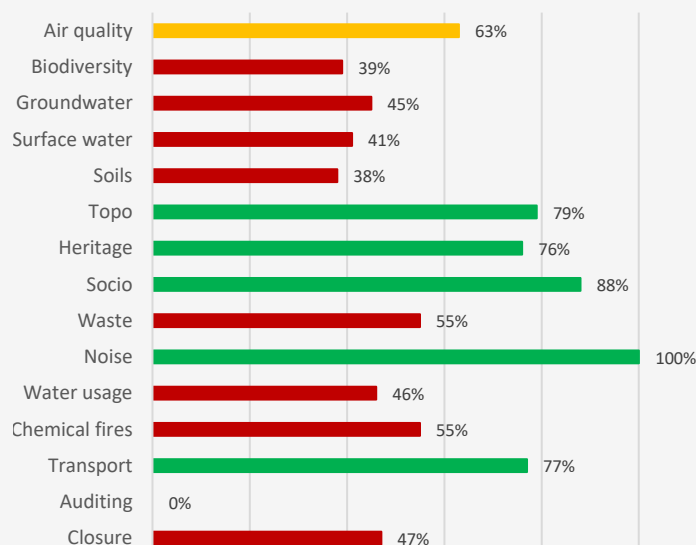
**Figure 1: EMP management areas (% compliance score)**

The EMP divided the management areas into 13 management areas (In Table 16 of EMP it is called potential impacts). The compliance per management area is shown in figure 1 (Based on Table 16 of EMP's potential impact column).

Although anything above 75% were highlighted in green, anything between 60% and 75% as yellow, and anything below 60% was highlighted in red, the obvious target is a 90-100% compliance.

Biodiversity, groundwater, surface water, soils, waste, water usage, chemical fires, auditing and closure were all management areas that were below average from both a performance and compliance perspective. The **soil** management and **biodiversity** management areas scored lowest
